Quality Assurance and Source Inspection

Contract #: 04-0120F4Cty: SF/ALA Rte: 80 PM: 13.2/13.9File #: 69.28**WELDING INSPECTION REPORT****Resident Engineer:** Pursell, Gary**Address:** 333 Burma Road**City:** Oakland, CA 94607**Report No:** WIR-004599**Date Inspected:** 10-Nov-2008**Project Name:** SAS Superstructure**OSM Arrival Time:** 1800**Prime Contractor:** American Bridge/Fluor Enterprises, a JV**OSM Departure Time:** 730**Contractor:** Zhenhua Port Machinery Company, Ltd (ZPMC), Changxing Island **Location:** Shanghai, China**CWI Name:****CWI Present:****Yes No****Inspected CWI report:** **Yes No N/A****Rod Oven in Use:****Yes No N/A****Electrode to specification:** **Yes No N/A****Weld Procedures Followed:****Yes No N/A****Qualified Welders:** **Yes No N/A****Verified Joint Fit-up:****Yes No N/A****Approved Drawings:** **Yes No N/A****Approved WPS:****Yes No N/A****Delayed / Cancelled:****Yes No N/A****Bridge No:** 34-0006**Component:** Tower**Summary of Items Observed:**

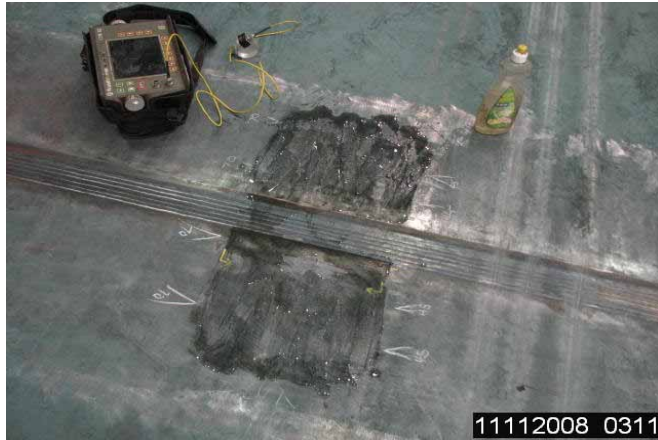
Heavy Shop 2: Caltrans QA inspector performed ultrasonic test (UT) inspection per ZPMC notification of witness inspection, document number 001385. The subassembly is identified as Lift 1 tower skin plate "A" splice plate weld, WSD1-SA1017A/J-17A. QA inspector observed that the welds have been UT inspected and identified as accepted by

ZPMC QC, Mr. Xu Ronggang. Caltrans QA-UT coverage was approximately 10%. The weld was found to be in conformance with the project specifications. See Caltrans Ultrasonic Test Report (TL-6027) dated, November 10, 2008 for additional information.

The following digital picture illustrates inspected weld.
